**SITE ASSESSMENT REPORT  
FOR F-16 CRASH SITE  
ALBANY COUNTY, WYOMING**

**VOLUME I**

**140th FIGHTER WING  
COLORADO AIR NATIONAL GUARD  
BUCKLEY AIR NATIONAL GUARD BASE  
AURORA, COLORADO**

**SEPTEMBER 1996**

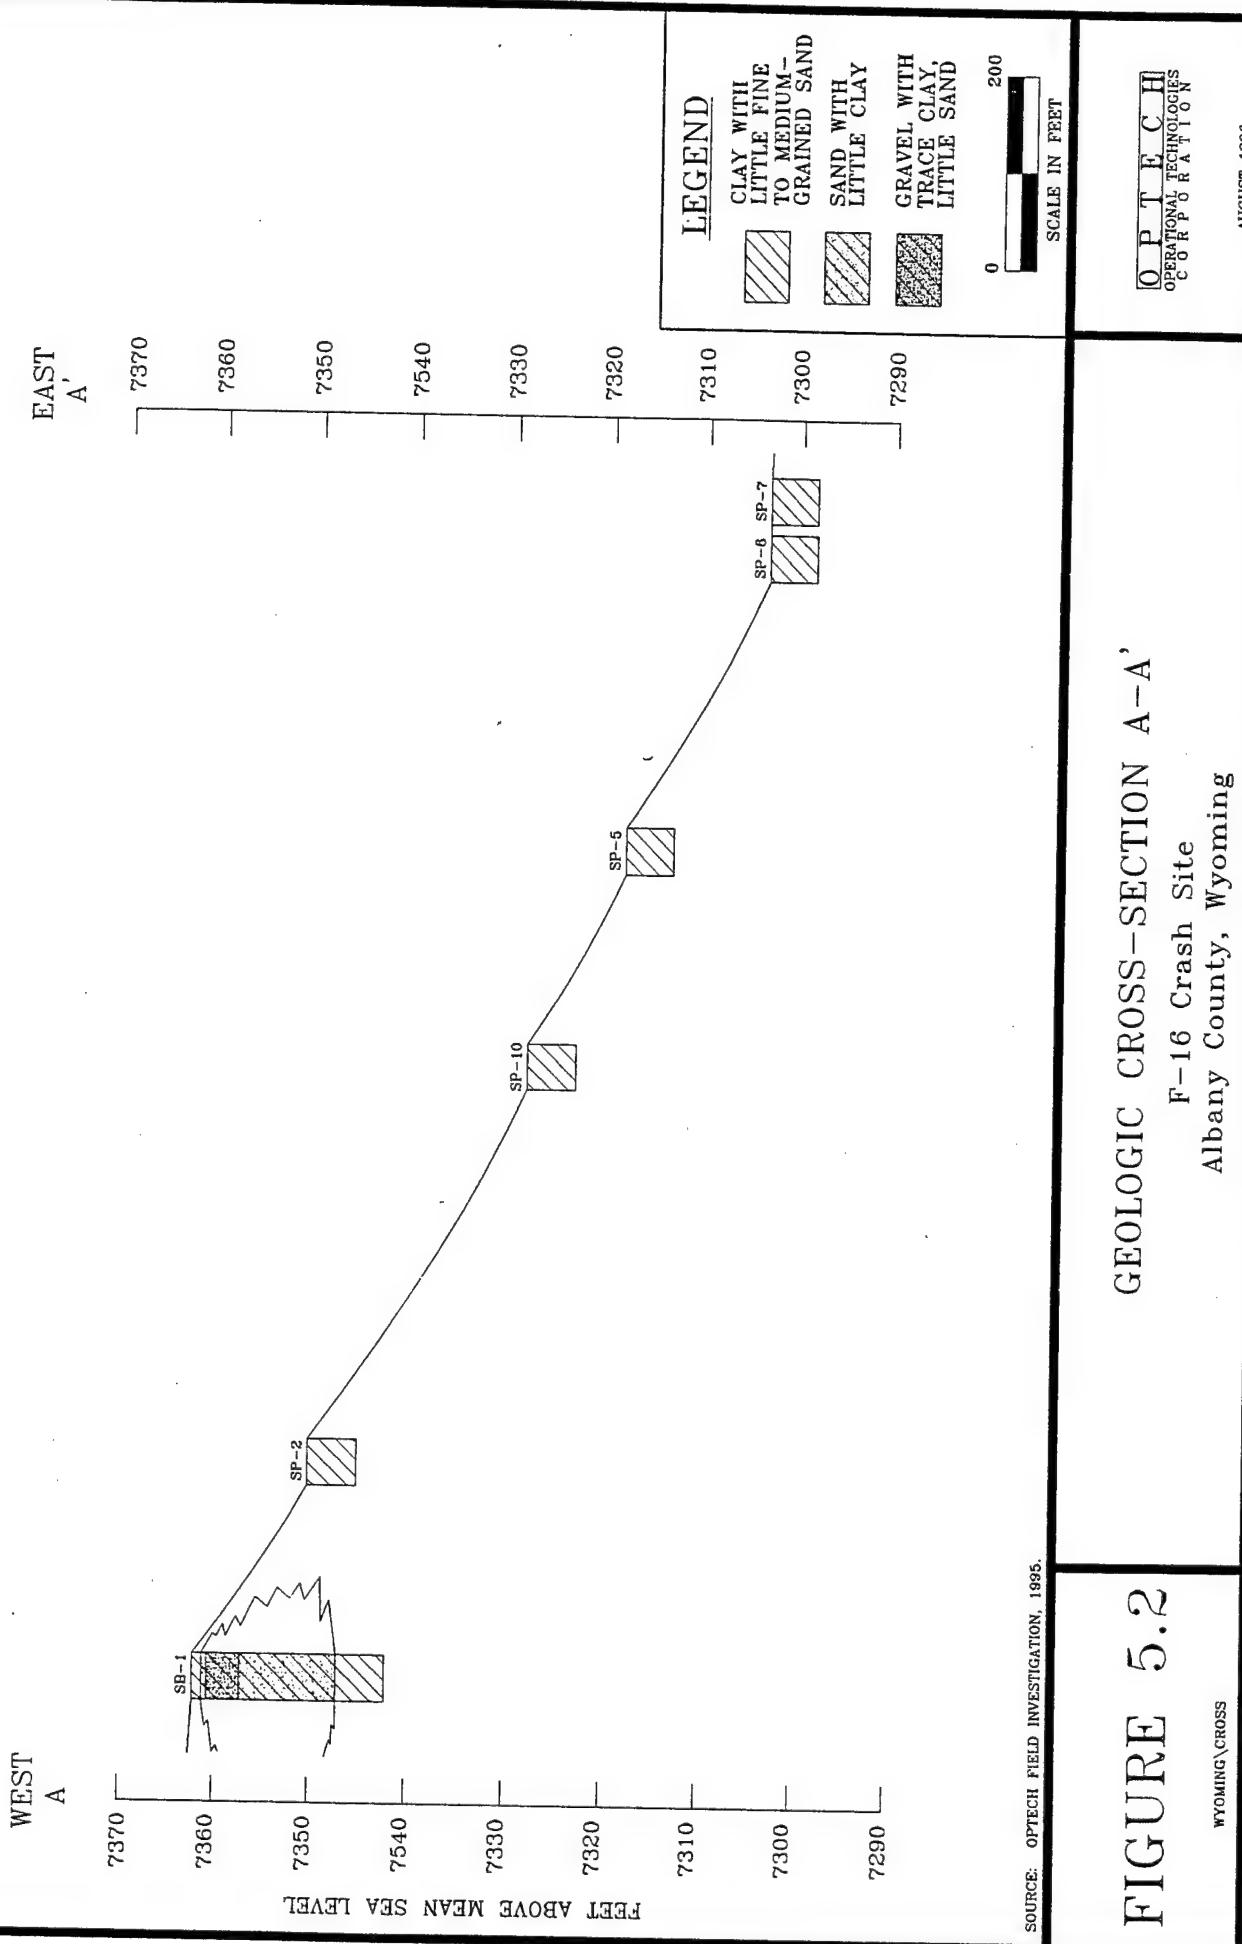
FIGURE 5.2

Light to medium brown clay with little fine- to medium-grained quartz sand was encountered from the surface to a depth of five feet BLS at most locations. An olive brown clay with fine-to medium-grained quartz sand with traces of iron oxide staining was encountered six feet BLS at SP6. Gravel consisting of quartz, granite, and chert pebbles with fine-to-very-coarse-grained quartz sand and trace clay was encountered from 5.0 to 6.5 feet BLS at SB1 within a sandy loam lense. The sandy loam lense consisted of fine- to medium-grained quartz sand with little clay and was encountered 1.5 to 16.5 feet BLS. Saturated conditions were not encountered to a depth of 20 feet BLS. Geologic cross-section A-A', depicting the subsurface geology, is indexed in Figure 5.1 and shown in Figure 5.2. Geoprobe Boring Logs are presented in Appendix D.
